Modification Instructions

ADC Solo
Type: 5155

Exchange of Display Cover

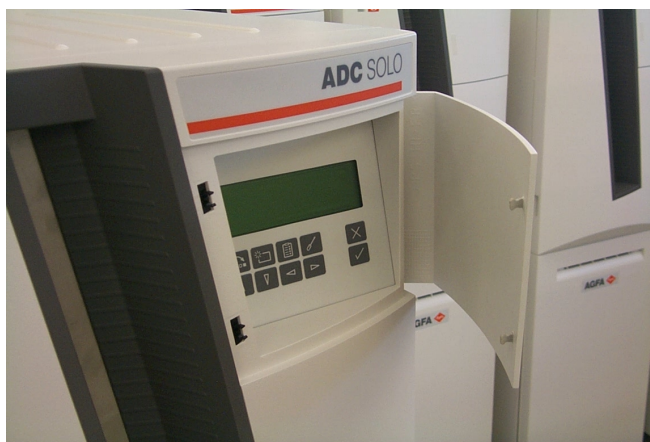
Figure 1

If the display cover has become defective during frequent operation there are three alternatives to replace the defective display cover depending, whether additional display covers are on stock or not.

Alternative 1 (if no display covers are on stock or if the locking mechanism is broken): Replace the whole front panel (CM+ 9.5155.1210.2) with a new one. Display covers will only be available for a short period of time. The old front panel design will be taken out of stock pretty soon.

Alternative 2 (if display covers are on stock and the hinge of the display cover is broken): Exchange the complete display cover including the hinge (CM+ 9.5155.9060.1).

Alternative 3 (if display covers are on stock and the hinge of the display cover is not broken): Remove the display cover from the hinge and insert a new one (CM+ 9.5155.9060.1).

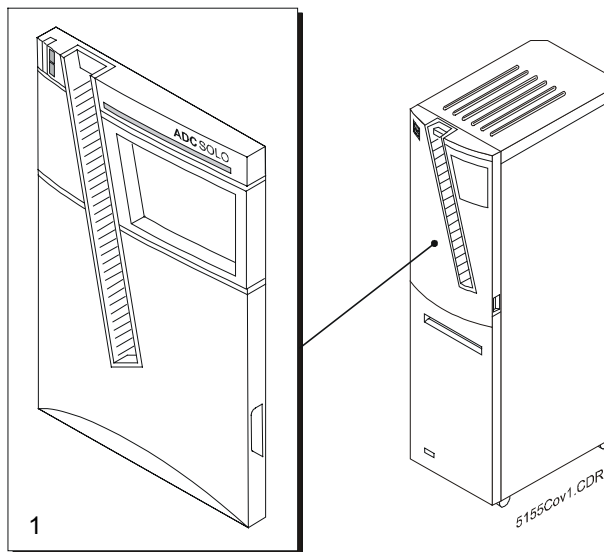
Figure 2

If no display covers are on stock or if the locking mechanism is broken: Exchange the entire front panel (CM+ 9.5155.1210.2).

1. Remove the right side panel (without tools).
2. Turn the screws of the left panel (quarter turn).
3. Remove the left side panel.
4. Open and remove phillips screws of top panel at rear of the digitizer.
5. Lift top panel and slide it towards the rear.
6. Open the three phillips screws along the left side and the three phillips screws along the right side of the front cover. Be careful with the washers.

7. Open the front door at the bottom of the digitizer.
8. Remove the front panel to be exchanged.
9. Insert the new front panel in reverse order of the described steps.
10. When you insert the new front panel make sure that the bores are in the right position.

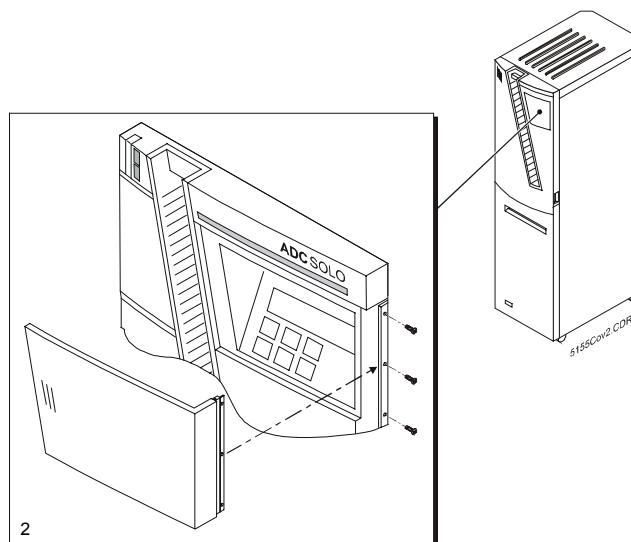
Figure 3

If display covers are on stock and the hinge of the display cover is broken: Exchange the complete display cover including the hinge (CM+9.5155.9060.1).

1. Remove right side panel.
2. Remove the three phillips screws of the plastic hinge. Use a phillips screw driver.
3. Pull the old hinge out of the frame.
4. Insert the new hinge into the frame.
5. Fix it with the phillips screws.

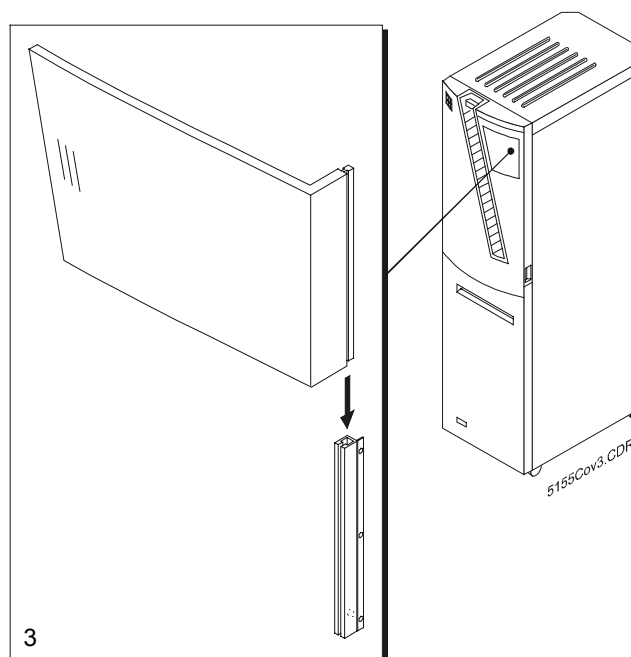
Figure 4

If display covers are on stock and the hinge of the display cover is not broken: Exchange the display cover only (CM+ 9.5155.9060.1).

1. Open the display cover.
2. Hit it gently but determined either from top or bottom and remove the old display cover by sliding it out of the hinge.
3. Insert the new display cover by sliding it into the rail of the hinge. Slide it until it exactly reaches the level of the hinge.
